**SITE INSPECTION REPORT
FOR
WOODRUFF AND EDWARDS
ELGIN, IL
ILD005071410
F05-8702-167
PAN: FIL0479SI**

SITE INSPECTION MEMO

DATE: March 30, 1987
TO: File
FROM: Dan Lombardi *D.L.*
SUBJECT: Illinois/F05-8702-167/FIL0479SI
Elgin/Woodruff and Edwards
ILD005071410

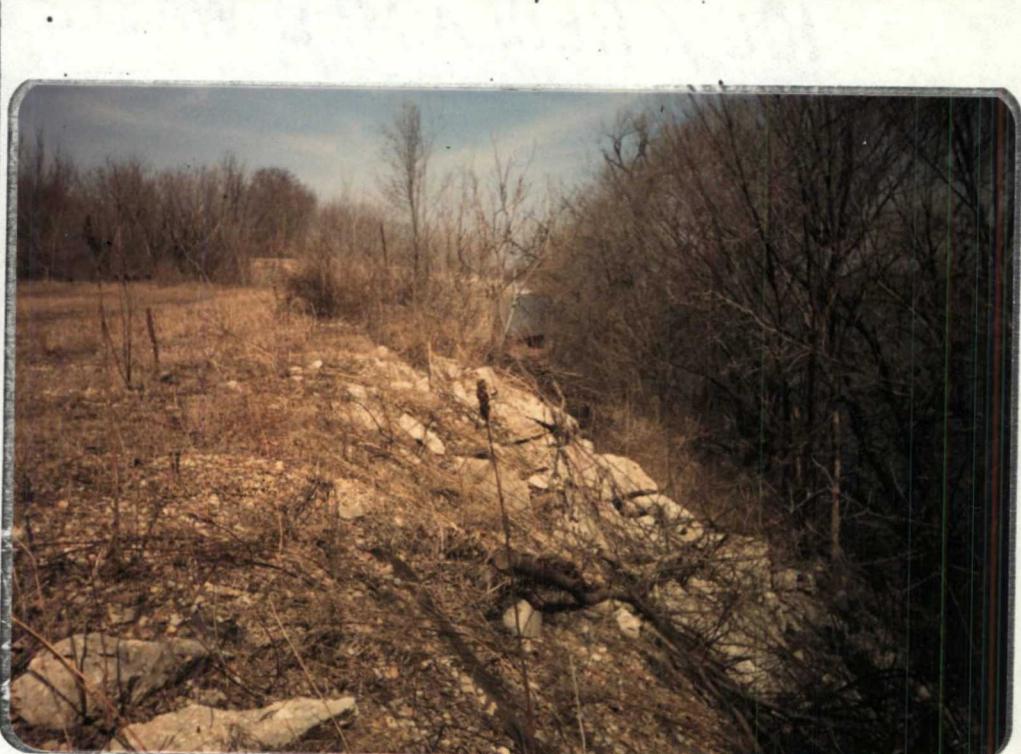
DESCRIPTION: EAST SLOPE OF THE OLD LANDFILL (SOUTH PARCEL)
ALONG THE WEST BANK OF THE FOX RIVER.DATE 3/23/87TIME 11:06 A.M. P.M.DIRECTION: N NNE NE ENE
E ESE SE SSE
S SSW SW WSW
W WNW NW NNWWEATHER 60°'s andSunnySITE Woodruff & EdwardsTDD# F05-8702-167

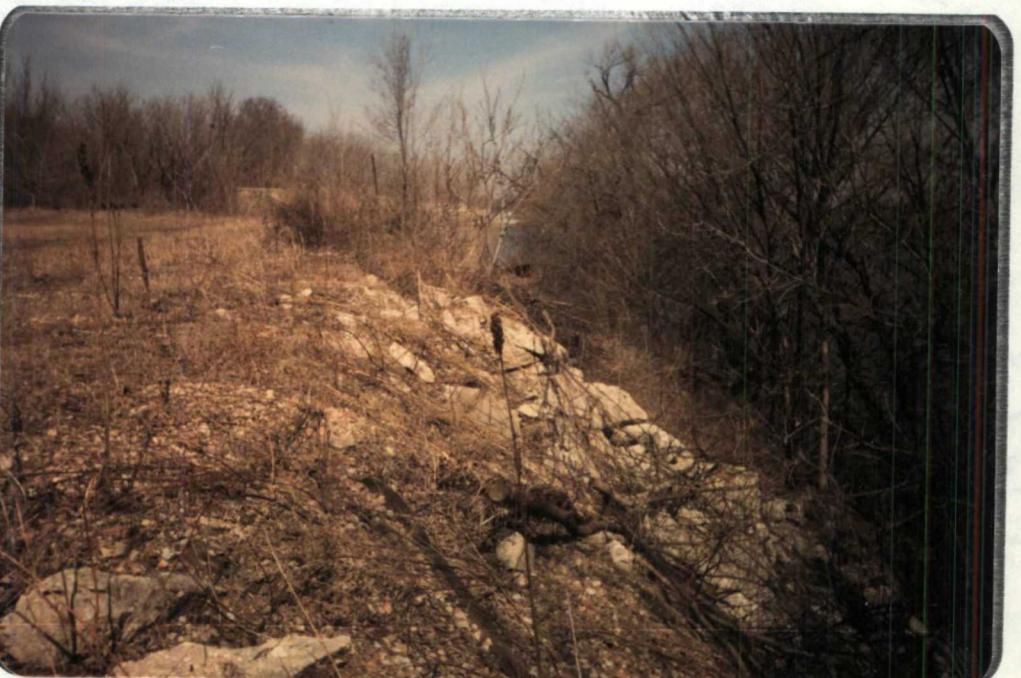
DESCRIPTION: SAME AS ABOVE.

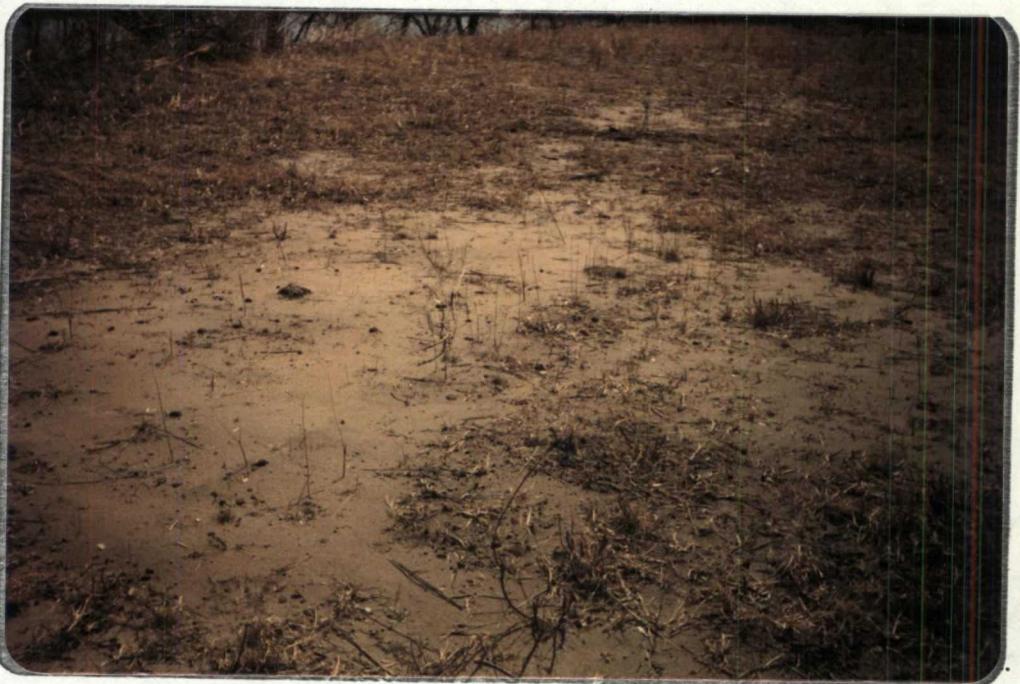
DESCRIPTION: OLD LANDFILL (SOUTH PARCEL) SURFACE COMPOSED OF SAND.DATE 3/23/87TIME 11:10 A.M.DIRECTION: N NNE NE ENE
E ESE SE SSE
S SSW SW WSW
W WNW NW NNWWEATHER 60's ANDSunnySITE Woodruff + EdwardsTDD# F05-8702-167

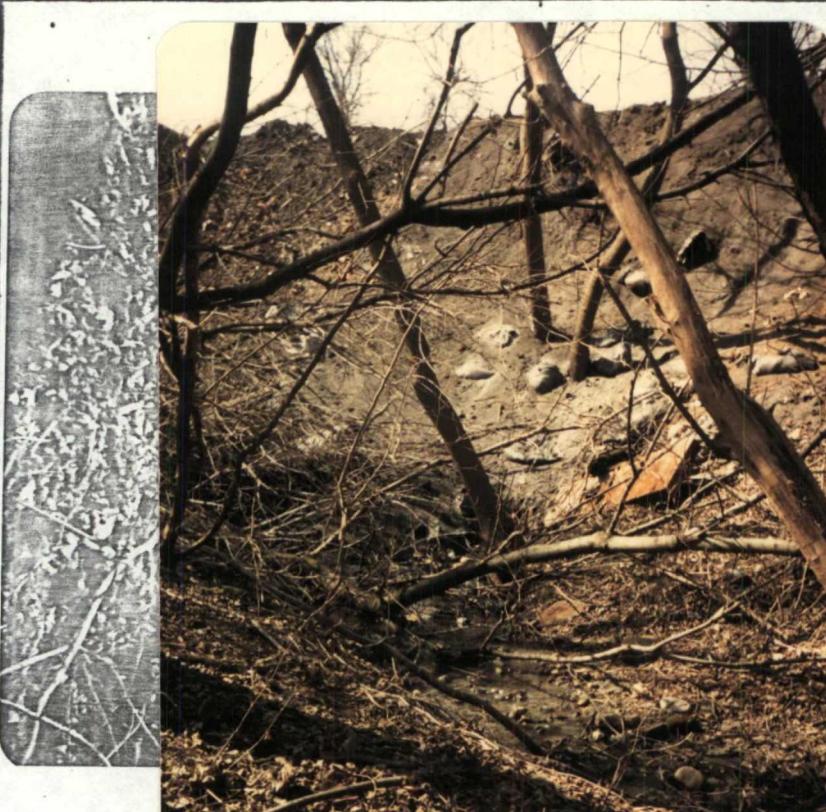
DESCRIPTION: EXPOSED FLY ASH BAGS (RECENT) ON SLOPE OF OLD LANDFILL (CENTRAL PARCEL).DATE 3/23/87TIME 11:20 A.M. P.M.

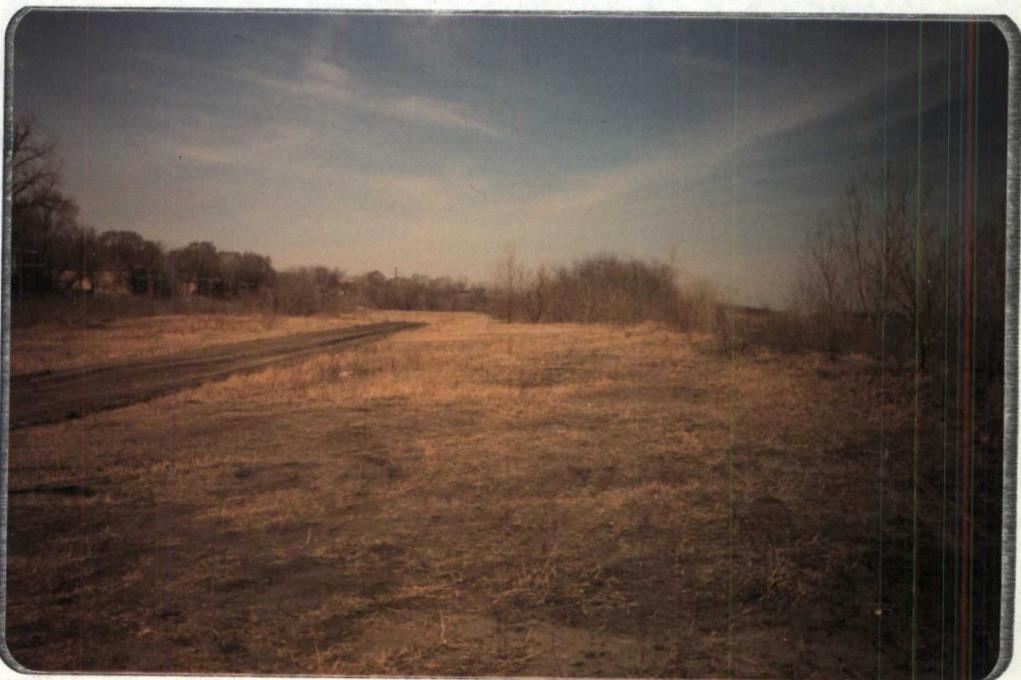
DESCRIPTION: OLD LANDFILL (CENTRAL PARCEL) PROPERTY. TOP OF LANDFILL SLOPES TO THE WEST.

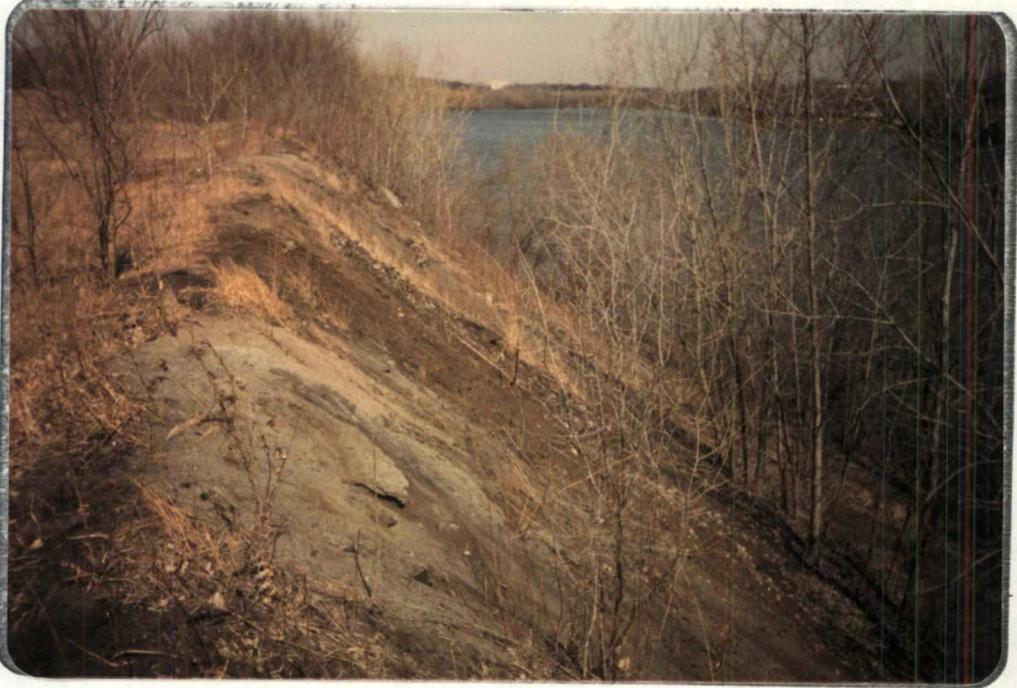
NO DIKE OR RETAINING WALL BETWEEN THE LANDFILL AND THE FOX RIVER.
SLOPE OF LANDFILL IS VERY STEEP (>50°) AND IS SUSCEPTIBLE TO SLOPE EROSION.
THE TOE OF THE LANDFILL IS 10 TO 12' FROM THE RIVER. WITH 100YR. FLOODPLAIN.

DESCRIPTION: EAST SLOPE OF OLD LANDFILL (CENTRAL PARCEL) IS
VERY STEEP (~50°) AND WITHIN 10-12' OF THE FOX RIVER.DATE 3/23/87TIME 11:31 A.M. P.M.DIRECTION: N NNE NE ENE
E ESE SE SSE
S SSW SW WSW
W WNW NW NNWWEATHER 60's AND
SunnySITE Woodruff + EdwardsTDD# FOS-8702-167

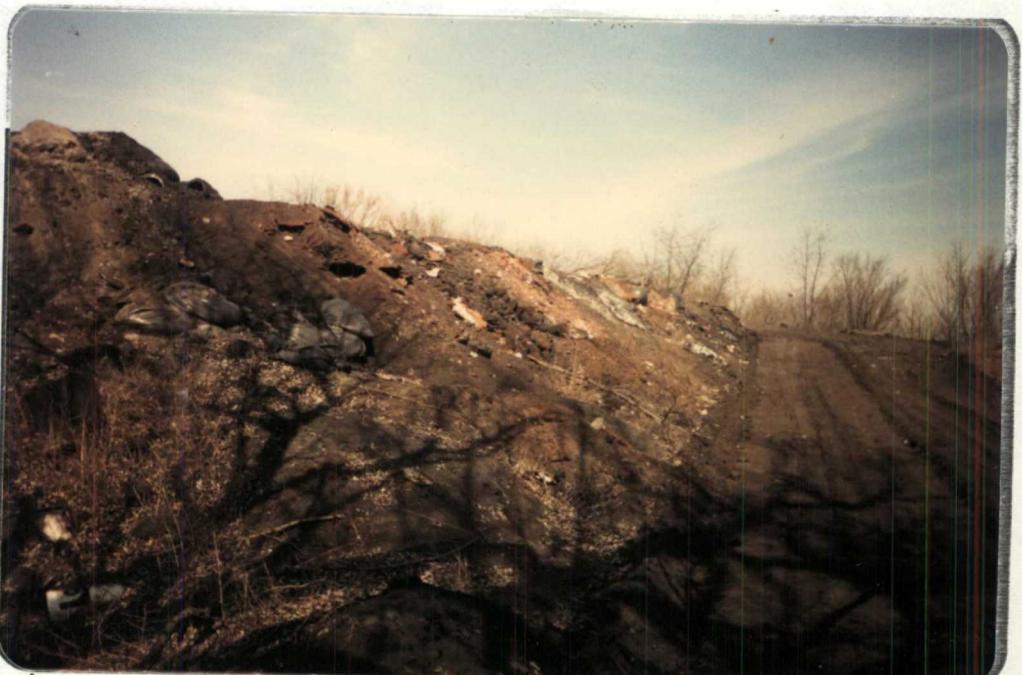
The landfill has a fairly good history of operation, but it has been in constant violation of IEPA regulations because of inadequate or lack of daily cover. Also, the landfill was observed to be very close to the Fox River.

DESCRIPTION: SOUTH ENTRANCE OF THE ACTIVE AREA (NORTH PARCEL).
EXPOSED BAGS OF FLY ASH - AND NO DAILY COVER.

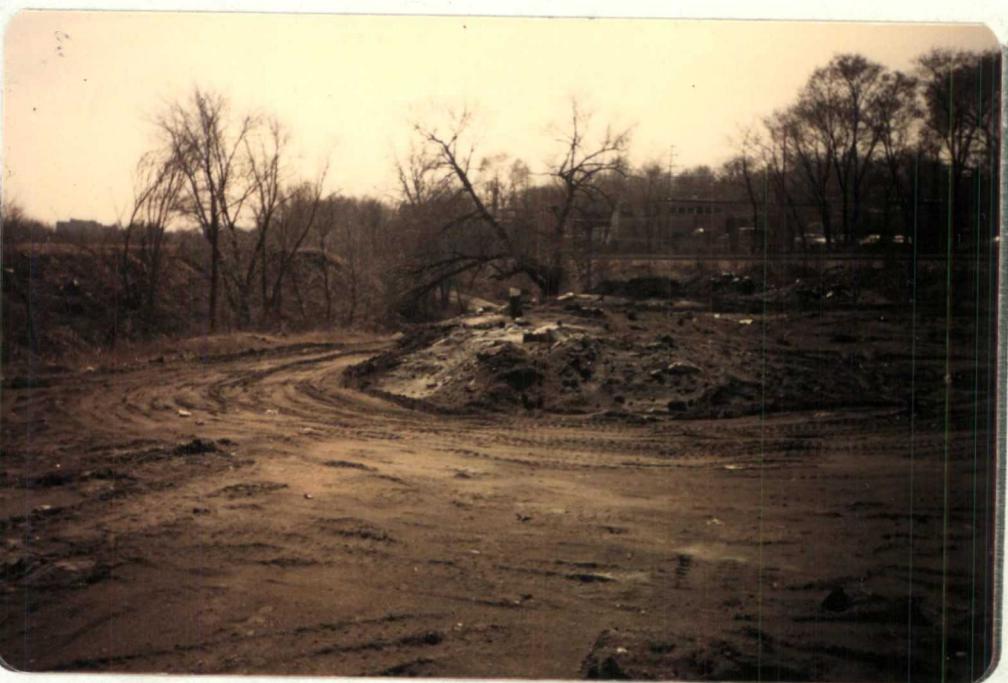
One employee is tasked to haul waste to the landfill as the fly ash is placed in tuff tote bags and covered with foundry sand. The northern most parcel is the active area where exposed and broken bags were observed in uncovered mounds and along the landfill slope (see photographs).

DESCRIPTION: ACTIVE AREA WITH UNCOVERED MOUNDS.DATE 3/23/87TIME 11:39 A.M. P.M.DIRECTION: N NNE NE ENE
E ESE SE SSE
S SSW SW WSW
W WNW NW NNWWEATHER b0's AND
SunnySITE Woodruff + EdwardsTDD# F05-8702-167

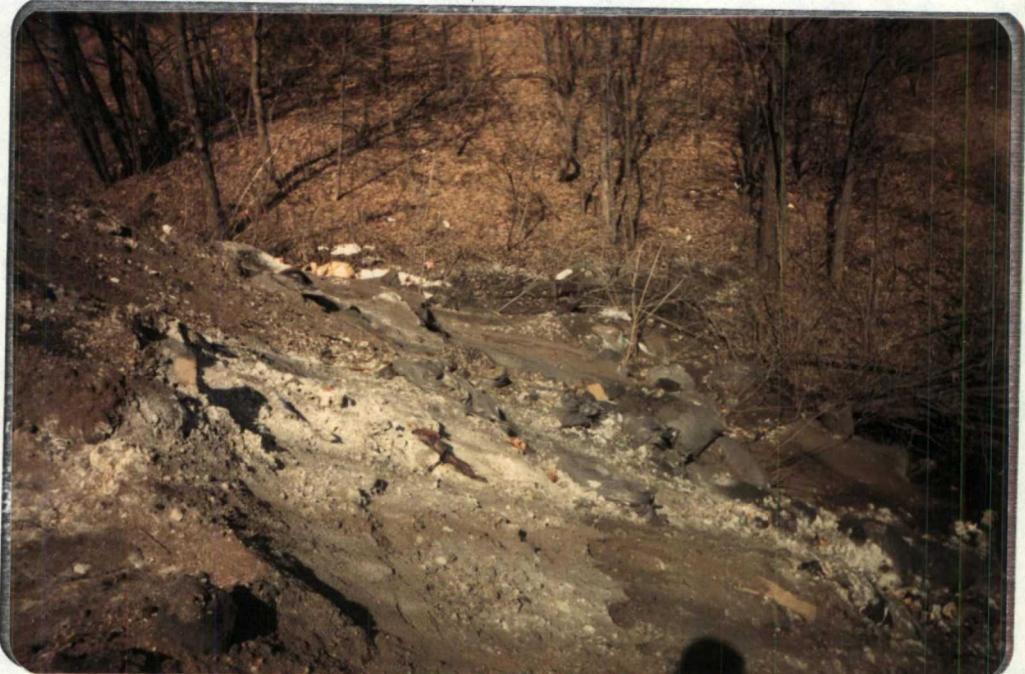
A very high potential exists for these metals to reach the Fox River via surface runoff. In addition, the toe and slope of the landfill are susceptible to slumping and slope erosion.

DESCRIPTION: NORTH EAST SLOPE OF THE ACTIVE AREA, EXPOSED
AND BROKEN BAGS OF FLY ASH AND NO COVER.

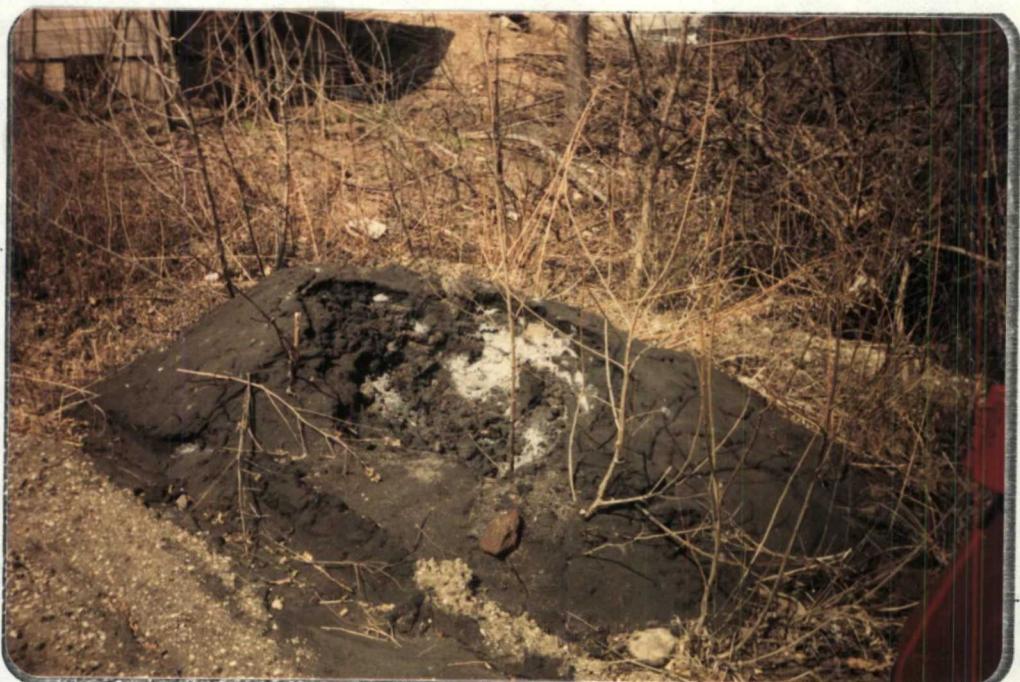
DESCRIPTION: NORTH SIDE OF ENTRANCE GATE. PILE OF FOULY
SAID AND WHITE PRECIPITATE MATERIAL.
